Chapter 4

Application of Implemented Plasticity to Slope Stability Analysis

4.1 Description of the Situation

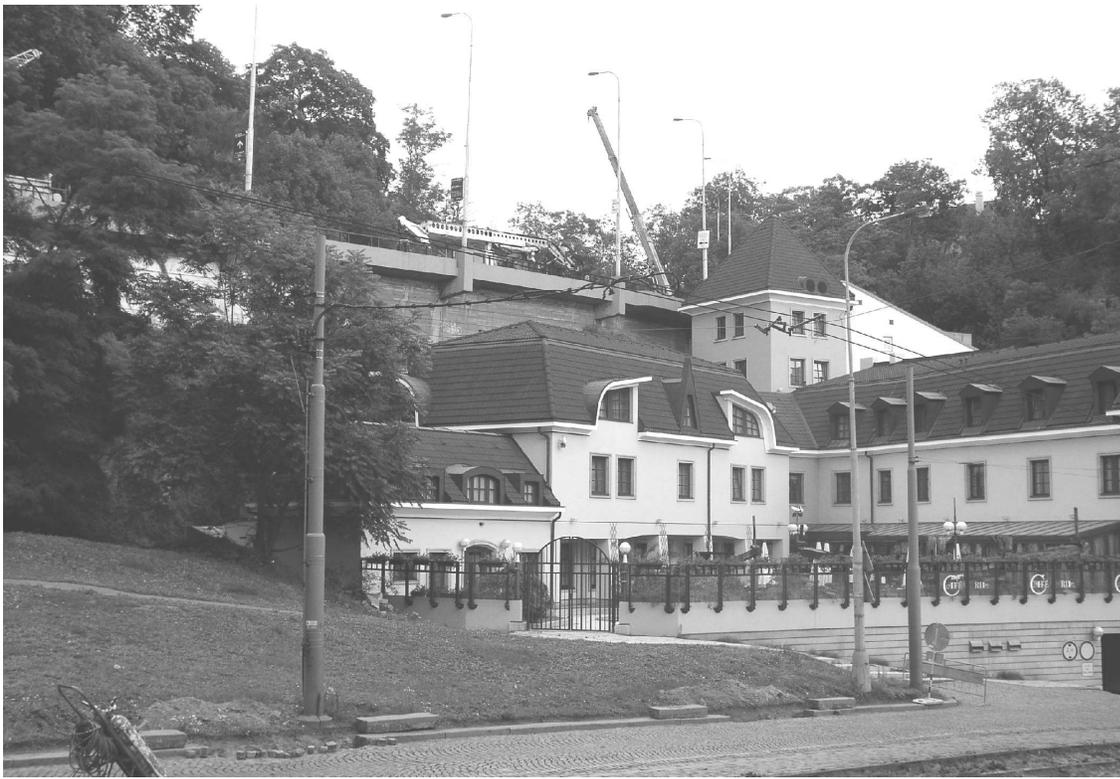
Figure 4.1: View of the eastern part of the cliff with the elevated road and of the hotel under the cliff. The upper part of the slope is at the upper left.

A slight but permanently unstable behavior of the elevated road carrying a roadway and tram tracks in both directions in the historical centre of Prague (Chotek road) and the ambient rock mass has been monitored for over twenty years. The movement values of the order of several millimetres per year have been measured. The upper part of the elevated road is founded on a heterogeneously stratified rock cliff. These phenomena resulted in the concern about the rock mass stability, particularly under the pier foundations. It was found necessary to analyze reliability and to assess the risk of the whole slope with the cliff in the very heterogeneously stratified Llandeilo stratum delb (the flysch zone of Prague Ordovician). The significance of the task was intensified by the position of the new "Hoffihotel" closely below the cliff - see Fig. (4.1) and (4.2).

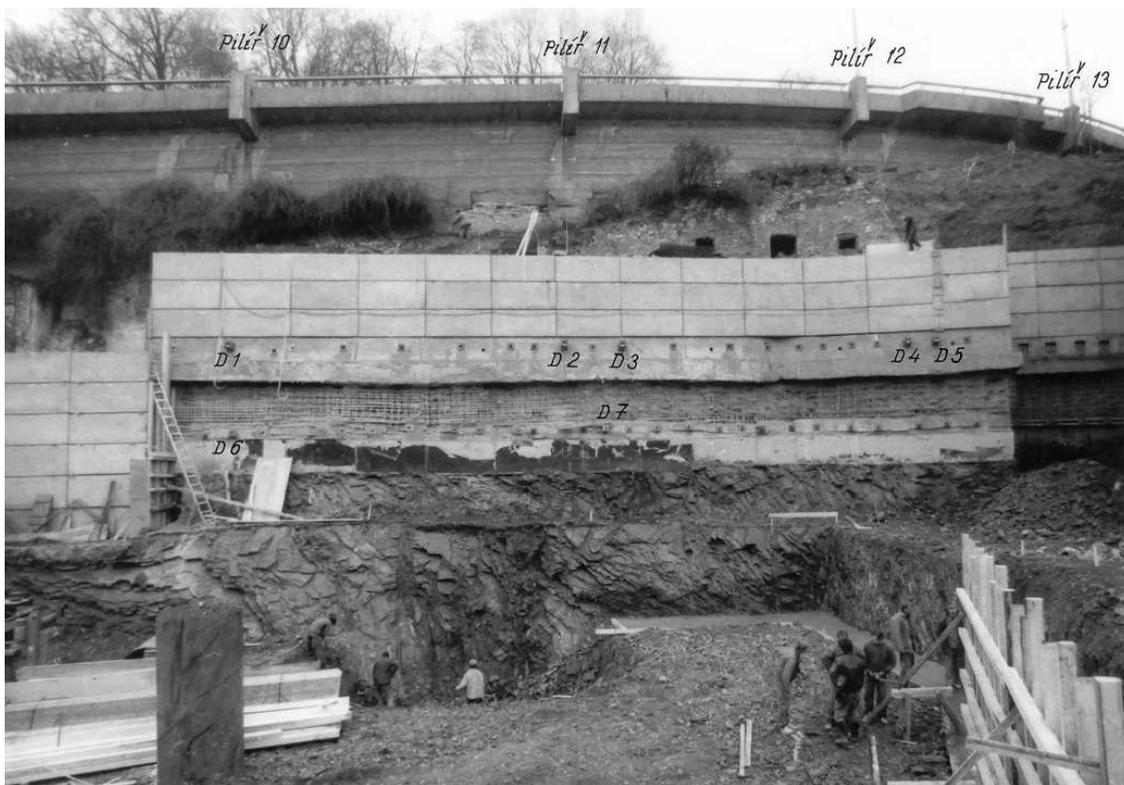
Figure 4.2: View of the excavation and temporary retaining structures of the hotel site. The elevated road is at the top.

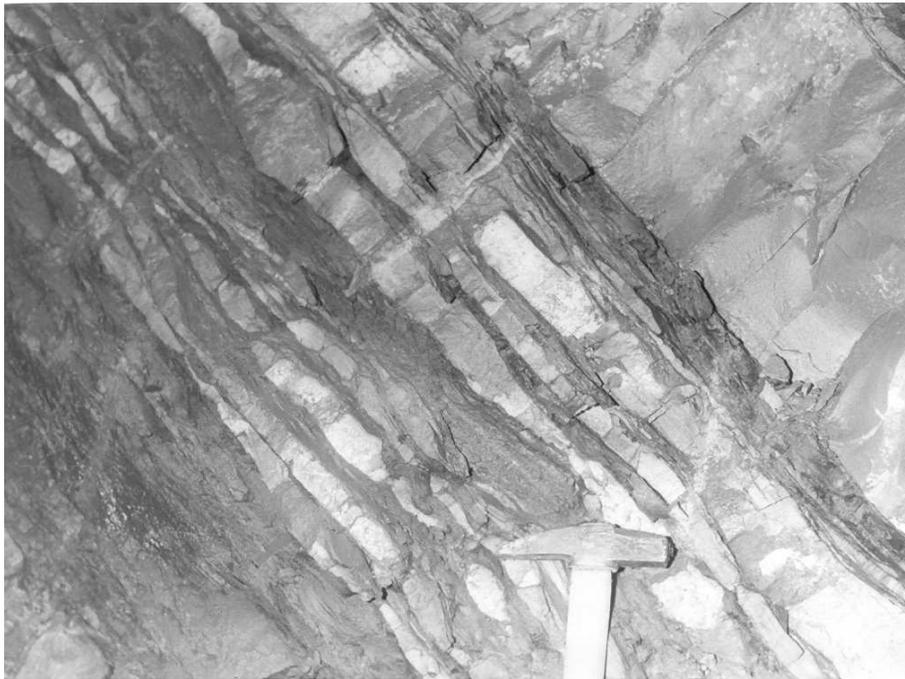
Figure 4.3: Detailed character of the Letná flysch strata with alternating schist and quartzite strata in the section under Pier No. 4.

times; the same applies also to ambient buildings. The elevated road was erected at the end of the 60s (1967-1969) of last century. The last interference with the slope in this area was the construction of the Hoffihotel in 1991. At that time the last buildings below the road were demolished and a part of the slope was excavated and secured by temporary anchorage and a precast revetment wall to make room for the hotel building. At present the road carries a tramway body over 8 m wide with two tracks and a single lane carriageway of variable width on its either side. On top of the elevated highway the upward lane is about 5 m and the downward lane is about 3.5 m wide. The cut in the slope above the road is secured by a masonry wall. The subject of the investigation was the risk of the elevated road structure on a steep slope with a rock cliff. The height of the cliff is about 25 m and in addition to that the height and the slope were increased by the excavations for the basement of the Hoffihotel building. The object of the analysis was the reliability and the risk of the rock mass under the footings of the elevated road piers, possibly the reliability and risk of the slope as a whole. The rock mass is covered with thin strata of slope sediments and made-up ground of unstable state. The rock mass strata crop out of the slope under the angle of 45° - 55° with a 0° - 7° skew and show polish on strata surfaces. The rock mass consists mostly of silty-sandy schist with frequent quartzite bands (of 30-120 mm thickness, as a rule, frequently 250 mm and exceptionally as many as 400 mm - see Fig. (4.3)). The surface of the rock mass is weathered to a depth of some 3 m.

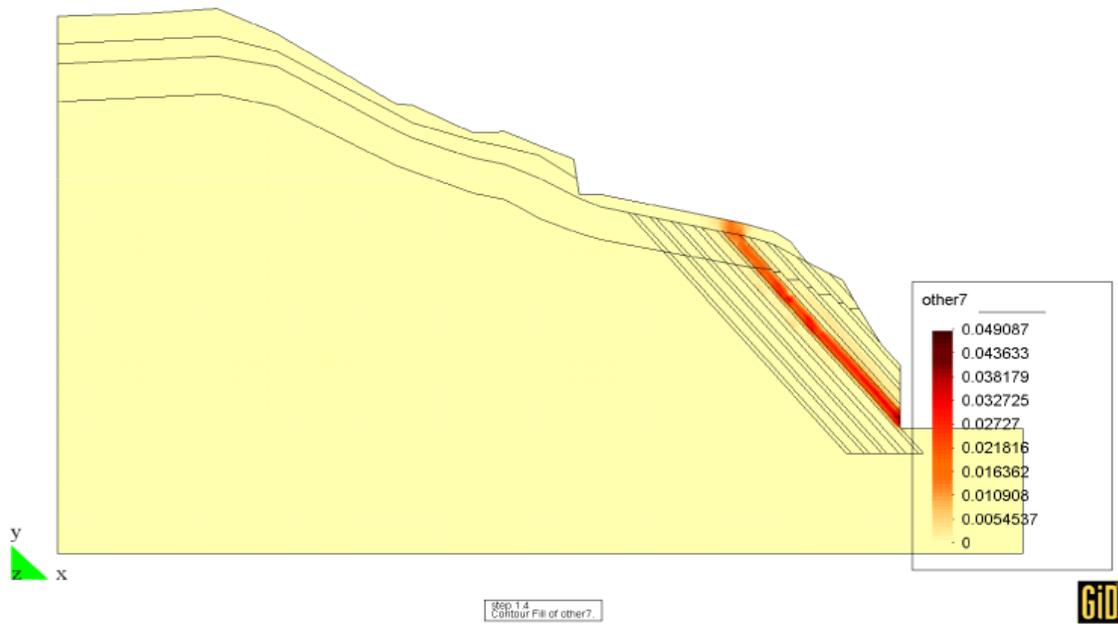
Figure 4.16: Segment of pier No. 10 (load combination 2, reached load factor $\lambda_f = 1.4$) : Plastic zones - values of consistency parameter
